## Technical bulletin N°2

**Reference** : BT\_2008\_FR20\_02  
**Date** : February 12<sup>th</sup>, 2008  
**Subject** : Rear hub modification

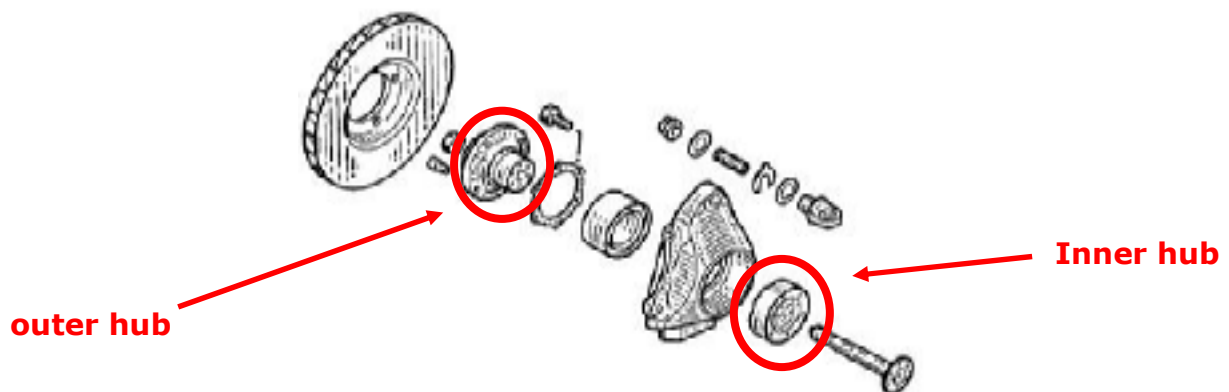
During the tightening of the rear hub, the retainers (outer and inner rear hubs) can come in contact. As a consequence, the preload of the bearing is not correctly achieved. This might create a mark on the shoulder of the outer hub, causing excessive wheel end play.

The retainers are the parts circled in red on the picture below:
