Technical Bulletin n°3

17th July, 2009

Reference: FR20_BT_2009_03_UK
Date: 17th July, 2009
Subject: Push-pull cable default
Parts: Push-pull cable

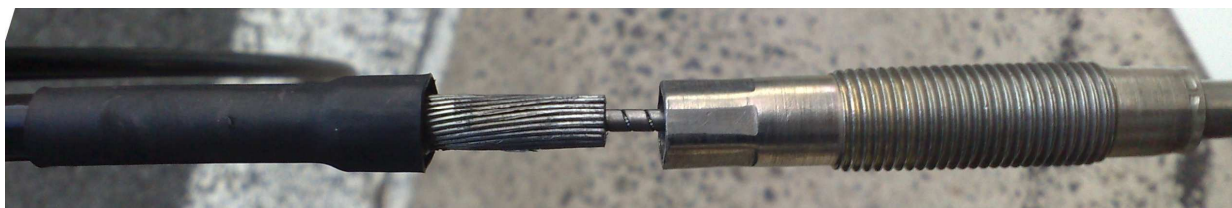
A production problem in 2 batches of push pull cable (Ref 77 11 154 263) has been detected. This concerns cables with the reference **"08/09"** or **"09/09"** written in white on the cable casing.

A crimping problem might appear after a few kilometres on some cables with these references, as shown below:

If you have such cables, check with your local Renault Sport spare parts dealer to arrange the exchange.

Otherwise, this exchange is also possible at the Renault Sport Spare parts truck for those who are participating in the Eurocup Formula Renault 2.0 in Le Mans this week end.
